**Flood Control Project Maintenance  
Levee Inspections****LMA District Cover Sheet  
Spring 2015 Levee Inspection Results****American River Flood Control District**

**Spring 2015 Levee Inspection Results**

**American River Flood Control District**

Waterway			Bank	Unit Miles
Unit No. 01 Arcade Creek			Left	2.08
	Spring (March - May)	Summer (June - August)	(September - November) Fall	Winter (December - February)
Unit Maintenance Rating (Fall Only)				
Date of Inspection	04/30/2015 - 04/30/2015			
DWR Inspector	Maksim Khashchuk			
Accompanied By	Richard Marck ARFCD

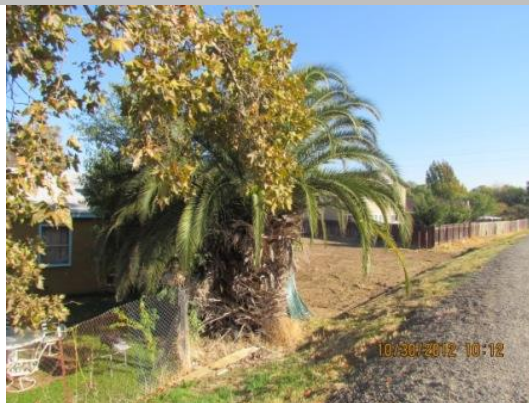
Photo 1 of 1 : SP\_2015\_NA0001\_58\_24\_20150317\_00021.jpg

LM Start	1.72	Rating **	M	Issue No.	24
LM End	1.72	Issue Type +	En	Location *	LS
Category	Earthen Levee			GPS Latitude/Longitude	
				Start	End
Item	Vegetation			38.628086 °	38.628086 °
				-121.439544 °	-121.439544 °
DWR ID	DWR_NA0001_07_s _ 2012_24				
Action/Comments					
Landscaping					
Inspector Comments: Palm tree was trimmed up.

View of palm tree within 10-ft of the levee toe trimmed up from previous inspection.

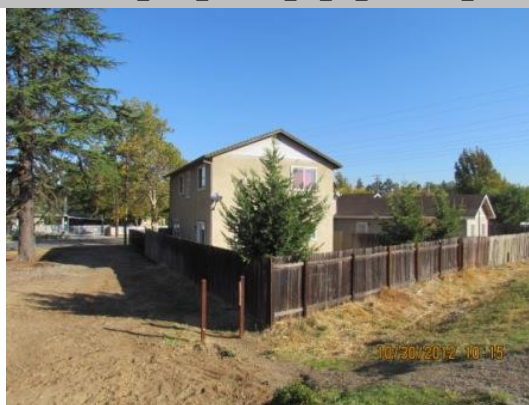
Photo 1 of 1 : SP\_2015\_NA0001\_58\_23\_20150317\_00020.jpg

LM Start	1.74	Rating **	U	Issue No.	23
LM End	1.74	Issue Type +	En	Location *	LS
Category	Earthen Levee			GPS Latitude/Longitude	
				Start	End
Item	Encroachments			38.628208 °	38.628208 °
				-121.439142 °	-121.439142 °
DWR ID	DWR_NA0001_07_s _ 2012_23				
Action/Comments					
Fence					
Inspector Comments: Wooden fence and cedar trees are within 10-ft of levee toe.

View of wooden privacy fence constructed at the toe.

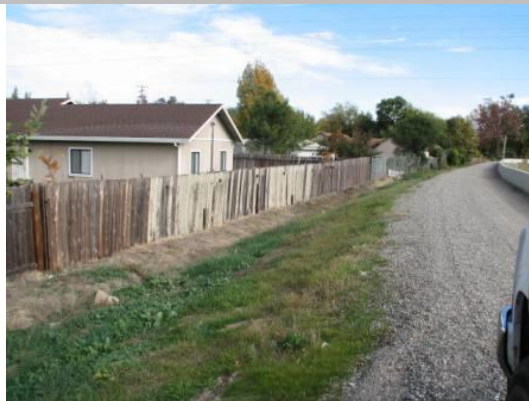
Photo 1 of 1 : SP\_2015\_NA0001\_58\_9\_20150317\_00007.jpg

LM Start	1.75	Rating **	U	Issue No.	9
LM End	1.75	Issue Type +	En	Location *	LS
Category	Earthen Levee			GPS Latitude/Longitude	
				Start	End
Item	Encroachments			38.628197 °	38.628197 °
				-121.438863 °	-121.438863 °
DWR ID	DWR_NA0001_07_s _ 2012_9				
Action/Comments					
Fence					
Inspector Comments: Wooden privacy fence is within 10-ft of the levee toe.

11/17/2011 Wooden privacy fence is constructed at the toe.

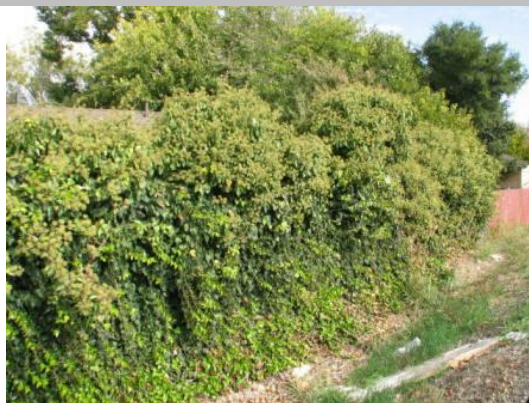
Photo 1 of 1 : SP\_2015\_NA0001\_58\_11\_20150317\_00009.jpg

LM Start	1.80	Rating **	U	Issue No.	11
LM End	1.80	Issue Type +	En	Location *	LS
Category	Earthen Levee			GPS Latitude/Longitude	
				Start	End
Item	Vegetation			38.628297 °	38.628297 °
				-121.437995 °	-121.437995 °
DWR ID	DWR_NA0001_07_f_2012_11				
Action/Comments					
Landscaping					
Inspector Comments: Dense ivy and landscaping planted on chain link fence on levee toe. Porch and awning are within 10-ft of the levee toe.

11/17/2011 Overgrown vegetation obstructs visibility and access.

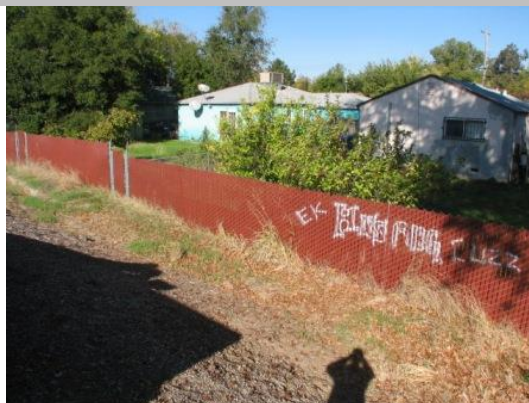
Photo 1 of 1 : SP\_2015\_NA0001\_58\_14\_20150317\_00012.jpg

LM Start	1.83	Rating **	M	Issue No.	14
LM End	1.83	Issue Type +	En	Location *	LS
Category	Earthen Levee			GPS Latitude/Longitude	
				Start	End
Item	Encroachments			38.628303 °	38.628303 °
				-121.437530 °	-121.437530 °
DWR ID	DWR_NA0001_07_s_2012_14				
Action/Comments					
Fence					
Inspector Comments: Chain link privacy fence is within 10-ft of levee toe.

Fall 2009 photo of privacy fence within 10-ft of the levee toe obstructs visibility and access.

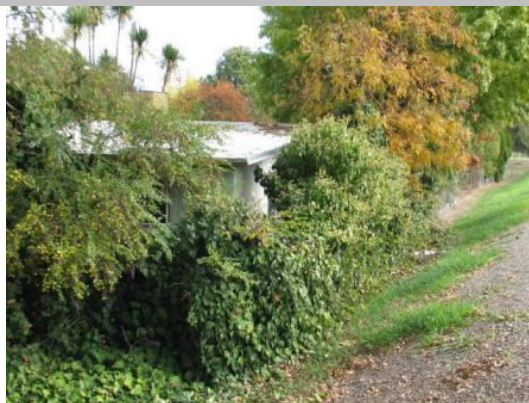
Photo 1 of 1 : SP\_2015\_NA0001\_58\_16\_20150317\_00015.jpg

LM Start	1.86	Rating **	U	Issue No.	16
LM End	1.86	Issue Type +	En	Location *	LS
Category	Earthen Levee			GPS Latitude/Longitude	
				Start	End
Item	Vegetation			38.628262 °	38.628262 °
				-121.436985 °	-121.436985 °
DWR ID	DWR_NA0001_07_s _ 2012_16				
Action/Comments					
Landscaping Inspector Comments: Dense ivy and trees along chain link fence on levee toe. Large building is within 10-ft of levee toe.

11/17/2011 Vegetation and building obstruct visibility and access to the levee toe.

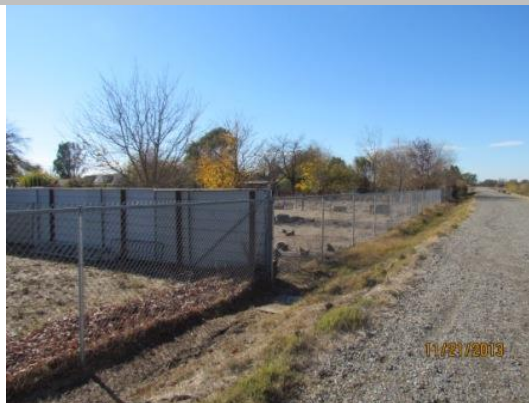
Photo 1 of 1 : SP\_2015\_NA0001\_59\_4\_20150317\_00004.jpg

LM Start	0.30	Rating **	M	Issue No.	4
LM End	0.49	Issue Type +	En	Location *	LS
Category	Earthen Levee			GPS Latitude/Longitude	
				Start	End
Item	Encroachments			38.668191 °	38.668118 °
				-121.442059 °	-121.438659 °
DWR ID	DWR_NA0001_08_s_2012_4				
Action/Comments					
Fence					
Inspector Comments: Chain link fence near levee toe limits access.

View of the chainlink fence at landside levee toe facing downstream.

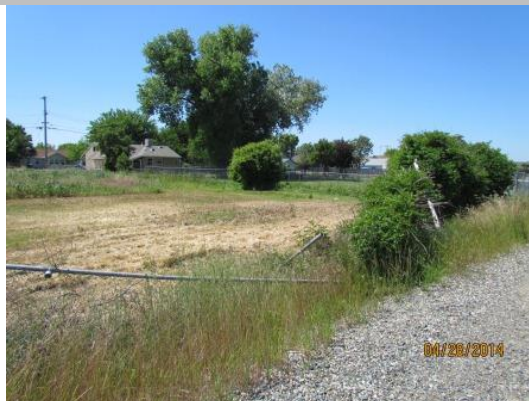
Photo 1 of 1 : SP\_2015\_NA0001\_59\_22\_20150317\_00013.jpg

LM Start	0.39	Rating **	M	Issue No.	22
LM End	0.39	Issue Type +	En	Location *	LS
Category	Earthen Levee			GPS Latitude/Longitude	
				Start	End
Item	Encroachments			38.668155 °	38.668155 °
				-121.440484 °	-121.440484 °
DWR ID	DWR_NA0001_08_s_2014_22				
Action/Comments					
Fence					
Inspector Comments: Remove fence from landside levee slope.

View of the broken fence on landside levee toe.

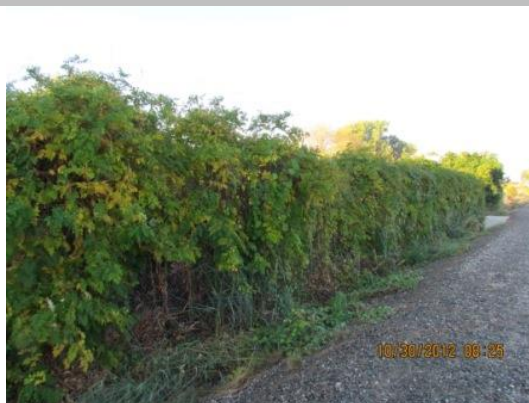
Photo 1 of 1 : SP\_2015\_NA0001\_59\_6\_20150317\_00005.jpg

LM Start	0.40	Rating **	M	Issue No.	6
LM End	0.43	Issue Type +	En	Location *	LS
Category	Earthen Levee			GPS Latitude/Longitude	
				Start	End
Item	Vegetation			38.668147 °	38.668141 °
				-121.440248 °	-121.439755 °
DWR ID	DWR_NA0001_08_s_2012_6				
Action/Comments					
Landscaping					
Inspector Comments: Vines on fence limit visibility.

View of the vines on fence obstructing visibility of landside toe.

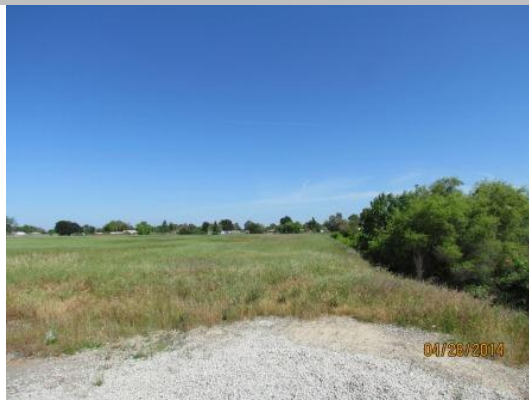
Photo 1 of 1 : SP\_2015\_NA0001\_59\_1\_20150317\_00001.jpg

LM Start	0.51	Rating **	U	Issue No.	1
LM End	1.03	Issue Type +	En	Location *	WS
Category	Earthen Levee			GPS Latitude/Longitude	
				Start	End
Item	Encroachments			38.668132 °	38.665528 °
				-121.438229 °	-121.431688 °
DWR ID	DWR_NA0001_08_s _ 2012_1				
Action/Comments					
Material Inspector Comments: This portion of the levee is inaccessible for maintenance.

View from downstream end of inaccessible portion of Magpie Creek due to landowner restrictions. There is no levee for ARFCD to maintain at this location. However, the channel maintenance is the responsibility of Sacramento Yard.

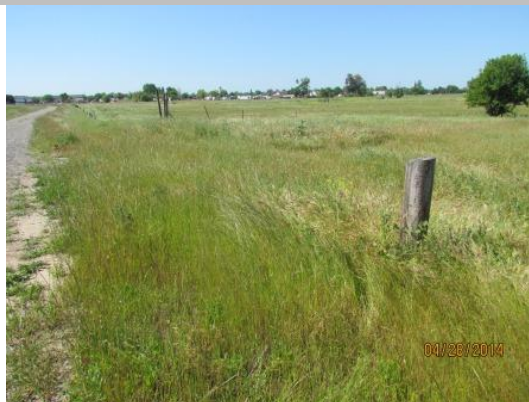
Photo 1 of 1 : SP\_2015\_NA0001\_59\_20\_20150317\_00011.jpg

LM Start	1.21	Rating **	M	Issue No.	20
LM End	1.21	Issue Type +	En	Location *	LS
Category	Earthen Levee			GPS Latitude/Longitude	
				Start	End
Item	Encroachments			38.662860 °	38.662860 °
				-121.431671 °	-121.431671 °
DWR ID	DWR_NA0001_08_s _ 2014_20				
Action/Comments					
Pole

View of the pole on landside levee toe.

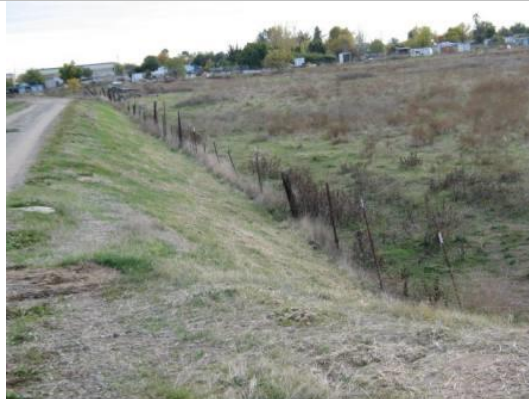
Photo 1 of 1 : SP\_2015\_NA0001\_59\_2\_20150317\_00002.jpg

LM Start	1.22	Rating **	M	Issue No.	2
LM End	1.31	Issue Type +	En	Location *	LS
Category	Earthen Levee			GPS Latitude/Longitude	
				Start	End
Item	Encroachments			38.662715 °	38.661584 °
				-121.431666 °	-121.431402 °
DWR ID	DWR_NA0001_08_s_2012_2				
Action/Comments					
Fence					
Inspector Comments: Barbed wire fence runs along the levee toe.

11/17/2011 Barbed wire fence at levee toe.

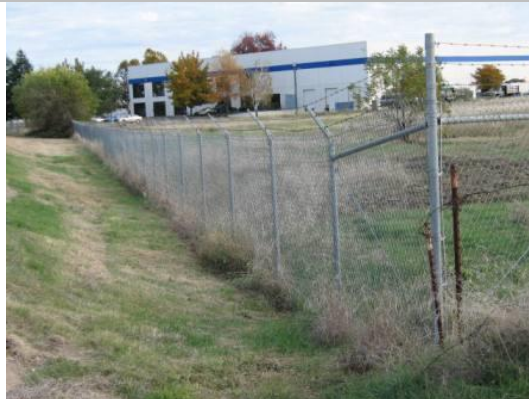
Photo 1 of 1 : SP\_2015\_NA0001\_59\_7\_20150317\_00006.jpg

LM Start	1.30	Rating **	M	Issue No.	7
LM End	1.33	Issue Type +	En	Location *	LS
Category	Earthen Levee			GPS Latitude/Longitude	
				Start	End
Item	Encroachments			38.661593 °	38.661370 °
				-121.431420 °	-121.430943 °
DWR ID	DWR_NA0001_08_s_2012_7				
Action/Comments					
Fence					
Inspector Comments: Cyclone fence with barbed wire within 10' of toe for part of its alignment.

11/17/2011 Chainlink fence at levee toe.

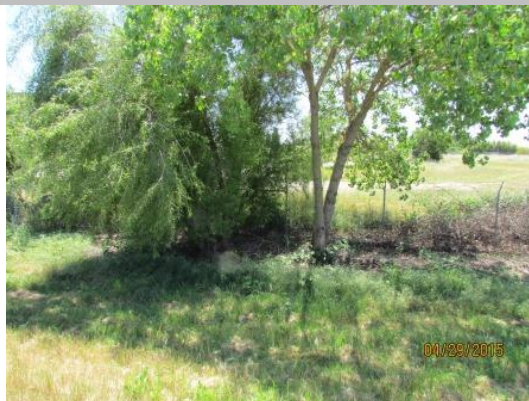
Photo 1 of 1 : SP\_2015\_NA0001\_59\_13\_20150504\_00017.jpg

LM Start	1.39	Rating **	M	Issue No.	13
LM End	1.39	Issue Type +	Ma	Location *	LS
Category	Earthen Levee			GPS Latitude/Longitude	
				Start	End
Item	Vegetation			38.660987 °	38.660987 °
				-121.430120 °	-121.430120 °
DWR ID	DWR_NA0001_08_s _ 2013_13				
Action/Comments					
Remove the wild growth other than native grasses from the levee slopes.					
Inspector Comments: The LMA has significantly improved this location and is in the final stages of exterminating invasive vegetation.

View of the woody vegetation to be removed from the landside levee toe.

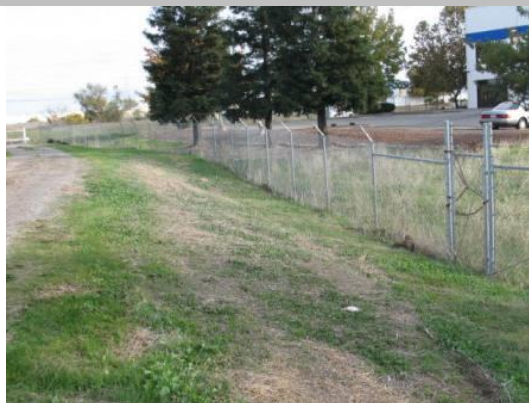
Photo 1 of 1 : SP\_2015\_NA0001\_59\_8\_20150317\_00007.jpg

LM Start	1.39	Rating **	M	Issue No.	8
LM End	1.43	Issue Type +	En	Location *	LS
Category	Earthen Levee			GPS Latitude/Longitude	
				Start	End
Item	Encroachments			38.660968 °	38.660828 °
				-121.430023 °	-121.429428 °
DWR ID	DWR_NA0001_08_s _ 2013_8				
Action/Comments					
Fence					
Inspector Comments: Cyclone fence alignment returns to within 10' of toe.

11/17/2011 Chainlink fence alignment returns to the levee toe.

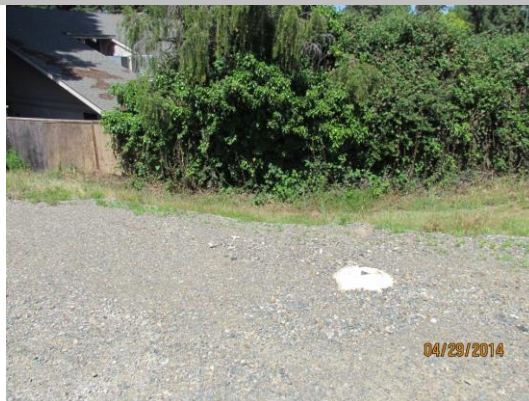
Photo 1 of 1 : SP\_2015\_NA0001\_60\_13\_20150317\_00006.jpg

LM Start	0.02	Rating **	A/W	Issue No.	13
LM End	0.02	Issue Type +	En	Location *	LS
Category	Earthen Levee			GPS Latitude/Longitude	
				Start	End
Item	Encroachments			38.567955 °	38.567955 °
				-121.383623 °	-121.383623 °
DWR ID	DWR_NA0001_09_f_2013_13				
Action/Comments					
Monitoring Well					
Inspector Comments: Monitoring well at landside levee hinge.

View of the monitoring well cap at the landside levee hinge.

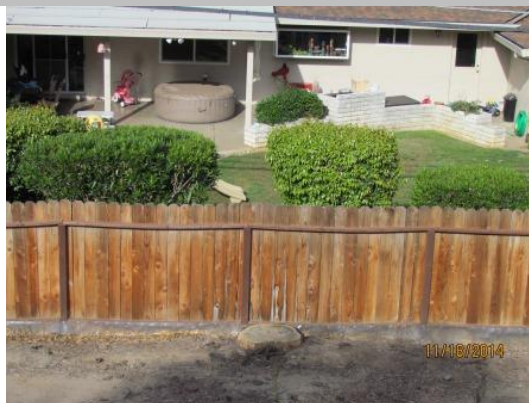
Photo 1 of 1 : SP\_2015\_NA0001\_60\_12\_20150317\_00005.jpg

LM Start	0.40	Rating **	N	Issue No.	12
LM End	0.40	Issue Type +	Ma	Location *	LS
Category	Earthen Levee			GPS Latitude/Longitude	
				Start	End
Item	Trim / Thin Trees			38.566725 °	38.566725 °
				-121.389935 °	-121.389935 °
DWR ID	DWR_NA0001_09_f_2013_12				
Action/Comments					
Tree stumps.

View of the tree stump at the landside levee toe.

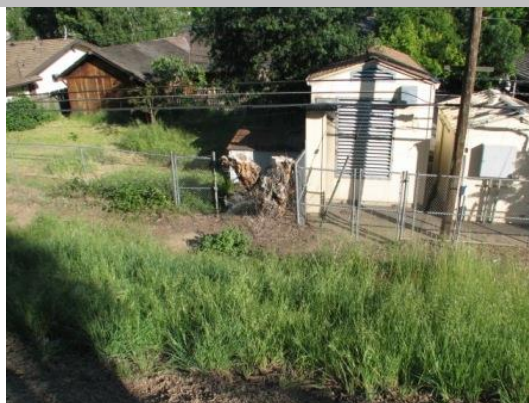
Photo 1 of 1 : SP\_2015\_NA0001\_60\_14\_20150317\_00007.jpg

LM Start	0.45	Rating **	N	Issue No.	14
LM End	0.45	Issue Type +	Ma	Location *	LS
Category	Earthen Levee			GPS Latitude/Longitude	
				Start	End
Item	Trim / Thin Trees			38.566298 °	38.566298 °
				-121.390680 °	-121.390680 °
DWR ID	DWR_NA0001_09_s_2012_14				
Action/Comments					
Tree stumps.					
Inspector Comments: Tree trunk at fence line.

Tree trunk at fence line.

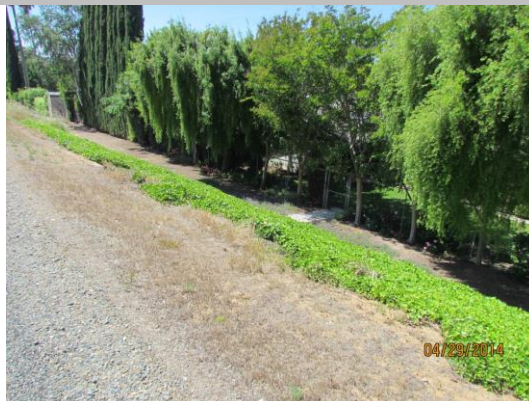
Photo 1 of 1 : SP\_2015\_NA0001\_60\_3\_20150317\_00003.jpg

LM Start	1.12	Rating **	M	Issue No.	3
LM End	1.12	Issue Type +	En	Location *	LS
Category	Earthen Levee			GPS Latitude/Longitude	
				Start	End
Item	Vegetation			38.563040 °	38.563040 °
				-121.402168 °	-121.402168 °
DWR ID	DWR_NA0001_09_s_2012_3				
Action/Comments					
Landscaping					
Inspector Comments: Ivy on slope

View of the landscaping at the levee toe.

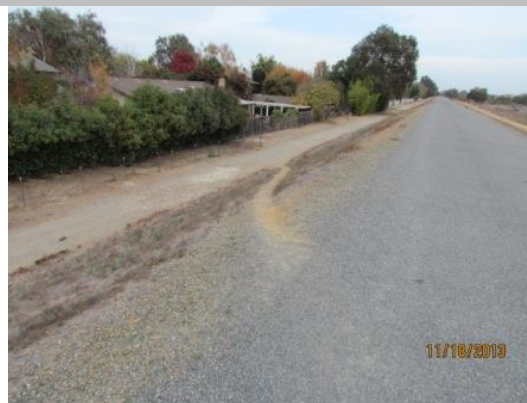
Photo 1 of 1 : SP\_2015\_NA0001\_61\_7\_20150317\_00004.jpg

LM Start	2.41	Rating **	A/W	Issue No.	7
LM End	2.41	Issue Type +	Ma	Location *	LS
Category	Earthen Levee			GPS Latitude/Longitude	
				Start	End
Item	Slope Stability			38.575126 °	38.575126 °
				-121.357575 °	-121.357575 °
DWR ID	DWR_NA0001_10_f_2013_7				
Action/Comments					
Repair the levee slope damaged by foot traffic and prevent access where possible.

View of the pathway on the landside levee slope.

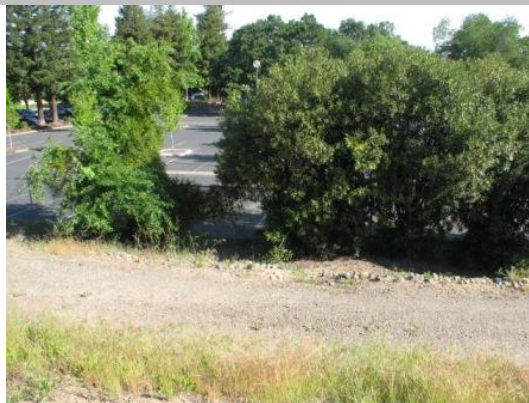
Photo 1 of 1 : SP\_2015\_NA0001\_61\_6\_20150317\_00003.jpg

LM Start	3.46	Rating **	M	Issue No.	6
LM End	3.46	Issue Type +	En	Location *	LS
Category	Earthen Levee			GPS Latitude/Longitude	
				Start	End
Item	Vegetation			38.569556 °	38.569556 °
				-121.375302 °	-121.375302 °
DWR ID	DWR_NA0001_10_s_2012_6				
Action/Comments					
Landscaping

Trees at fence line obstruct access and visibility.

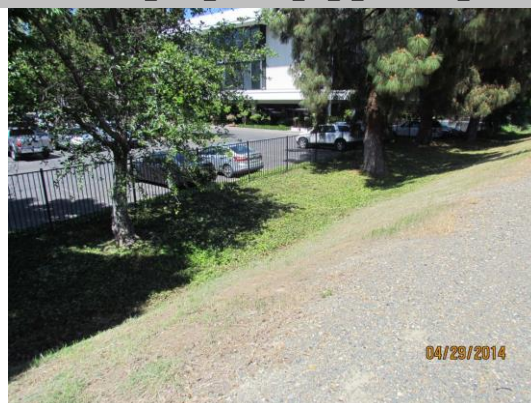
Photo 1 of 1 : SP\_2015\_NA0001\_61\_4\_20150317\_00002.jpg

LM Start	3.75	Rating **	M	Issue No.	4
LM End	3.84	Issue Type +	En	Location *	LS
Category	Earthen Levee			GPS Latitude/Longitude	
				Start	End
Item	Vegetation			38.568492 °	38.568076 °
				-121.380477 °	-121.382001 °
DWR ID	DWR_NA0001_10_s_2012_4				
Action/Comments					
Landscaping					
Inspector Comments: Ivy and trees.

View of the landscaping at the landside levee toe and slope.

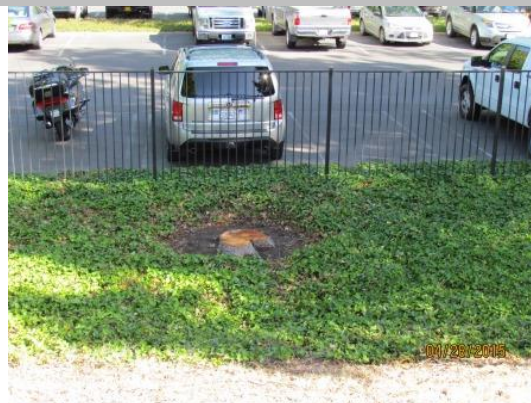
Photo 1 of 1 : SP\_2015\_NA0001\_61\_23\_20150504\_00016.jpg

LM Start	3.83	Rating **	N	Issue No.	23
LM End	3.83	Issue Type +	Ma	Location *	LS
Category	Earthen Levee			GPS Latitude/Longitude	
				Start	End
Item	Trim / Thin Trees			38.568111 °	38.568111 °
				-121.381896 °	-121.381896 °
DWR ID	DWR_NA0001_10_s_2015_23				
Action/Comments					
Tree stumps.

View of the tree stump at the landside levee toe.

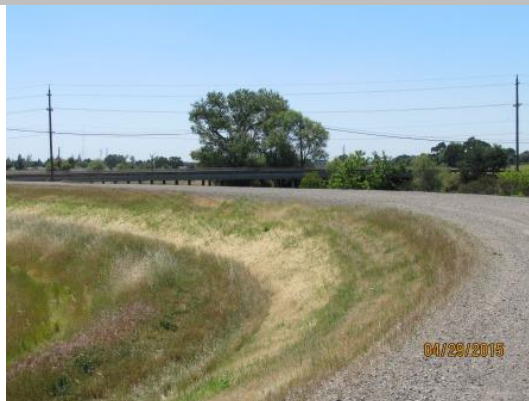
Photo 1 of 1 : SP\_2015\_NA0001\_436\_5\_20150504\_00005.jpg

LM Start	0.59	Rating **	A	Issue No.	5
LM End	0.59	Issue Type +	Ma	Location *	LS
Category	Earthen Levee			GPS Latitude/Longitude	
				Start	End
Item	Vegetation			38.667912 °	38.667912 °
				-121.449981 °	-121.449981 °
DWR ID	DWR_NA0001_11_s_2015_5				
Action/Comments					
Control annual grass and weeds on the levee slopes and easements.

View of the acceptable vegetation control on the levee slope.

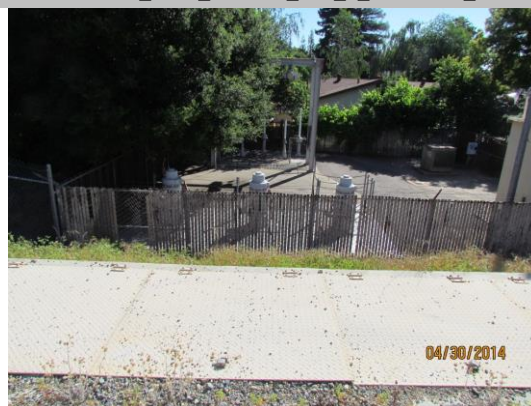
Photo 1 of 1 : SP\_2015\_NA0001\_438\_4\_20150317\_00004.jpg

LM Start	0.05	Rating **	A/W	Issue No.	4
LM End	0.05	Issue Type +	En	Location *	LS
Category	Earthen Levee			GPS Latitude/Longitude	
				Start	End
Item	Encroachments			38.570691 °	38.570691 °
				-121.353550 °	-121.353550 °
DWR ID	DWR_NA0001_12_s_2014_4				
Action/Comments					
Pipe					
Inspector Comments: 3 pipes across levee.

View of the pumping facility at the landside levee toe.

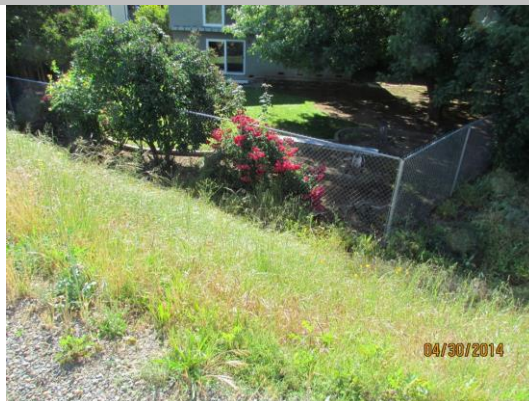
Photo 1 of 1 : SP\_2015\_NA0001\_438\_2\_20150317\_00002.jpg

LM Start	0.08	Rating **	M	Issue No.	2
LM End	0.08	Issue Type +	En	Location *	LS
Category	Earthen Levee			GPS Latitude/Longitude	
				Start	End
Item	Vegetation			38.571036 °	38.571036 °
				-121.353441 °	-121.353441 °
DWR ID	DWR_NA0001_12_s_2014_2				
Action/Comments					
Landscaping

View of the landscaping at the landside levee toe.

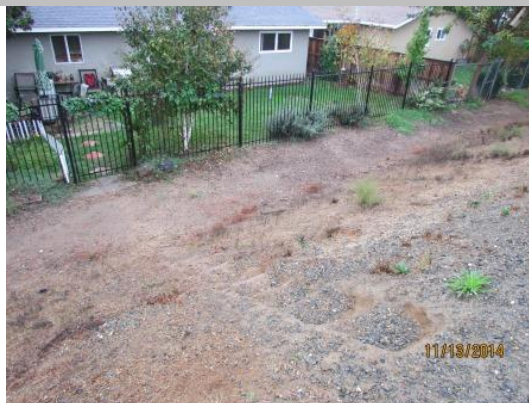
Photo 1 of 1 : SP\_2015\_NA0001\_438\_1\_20150317\_00001.jpg

LM Start	0.20	Rating **	M	Issue No.	1
LM End	0.20	Issue Type +	En	Location *	LS
Category	Earthen Levee			GPS Latitude/Longitude	
				Start	End
Item	Encroachments			38.572016 °	38.572016 °
				-121.351633 °	-121.351633 °
DWR ID	DWR_NA0001_12_f_2014_1				
Action/Comments					
Stairway

View of the stairs on the landside levee slope.
